HOME INSPECTION REPORT

Anywhere, Hagerstown , MD 21742

Tuesday September 1, 2015

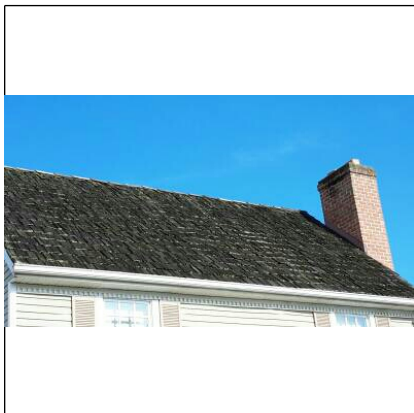
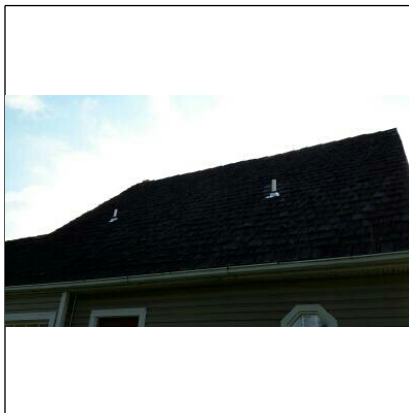
Roof inspection was limited to inspecting from the ground with binoculars due to pitch and type (wood shakes).

Comments Roof appeared to be nearing end of its useful life, budget to replace soon.

Roof is nearing end of its useful life.
Water heater that is 5+ years.

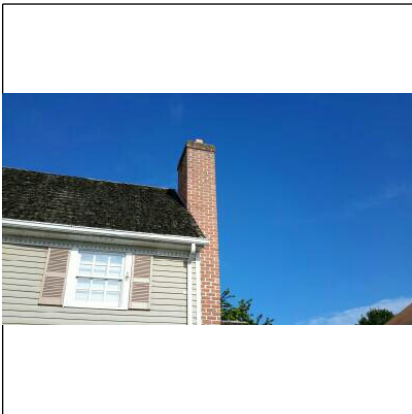
Comments
 Chimney flue was not accessible so not evaluated

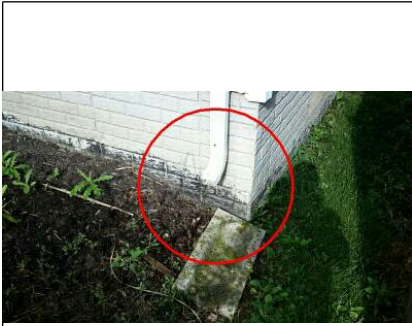
Gutter extension recommended

Comments
 Gutters had some rusted through holes, recommend repair/replacement of damaged sections
 Recommend maintaining downspout discharge a minimum of 5-6' away from the house.

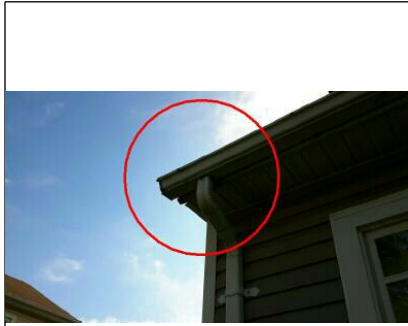
Leaking gutter.

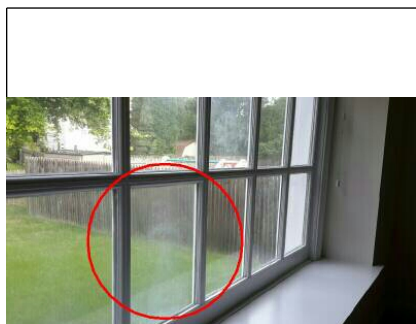
- Condition** Satisfactory Marginal Poor Wood rot Recommend repair/painting
- Recommend repair/replace damaged screens Failed/fogged insulated glass
- Material** Wood Metal Vinyl Aluminum/Vinyl clad
- Screens** Torn Bent Not installed Satisfactory
- Comments** Recommend repair/replacement of failed/fogged insulated glass in dining room window.

Leaking insulated glass.

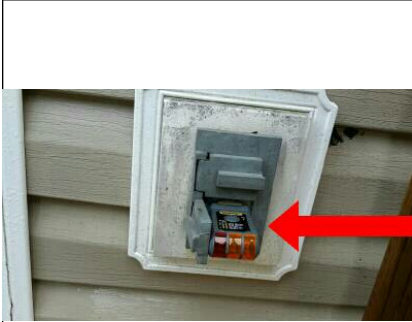
Receptacle not operating at time of inspection recommend replace/repair with GFCI outlet by qualified electrician.

Bottom leg of exterior outlet located near rear entrance door. Recommend qualified electrician evaluate / repair the outlet. For additional safety recommend it be GFCI outlet.

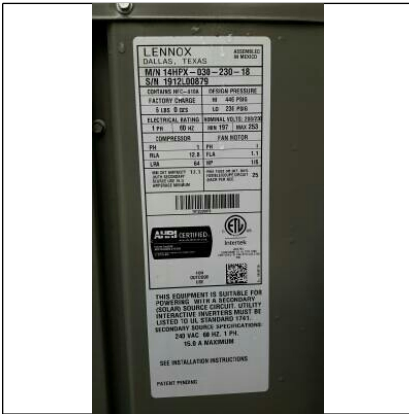
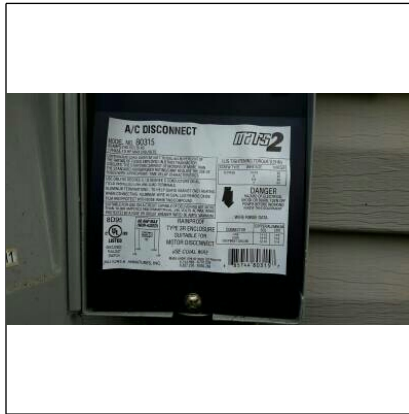
Comments Heat pump was operated in cooling mode only due to outside temperature.

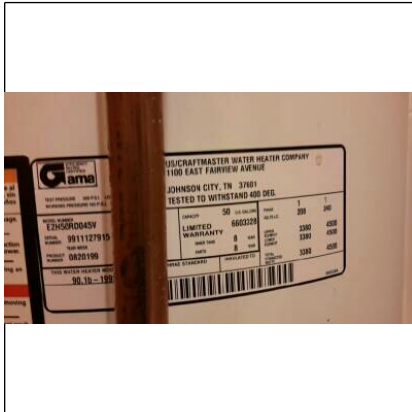
Comments Marginal due to water heater age recommend it being a deferred cost item.

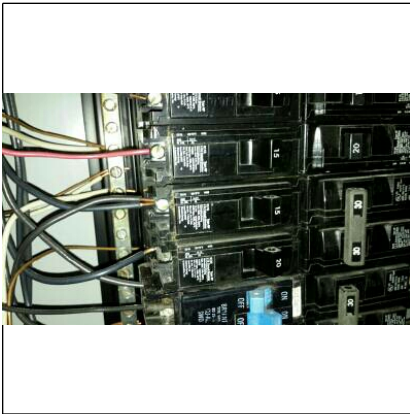
Comments B reaker is double-tapped - this is a safety concern. Recommend licensed electrician evaluate and make necessary repairs

Double tap breaker, recommend qualified electrician evaluate / repair.
Recommend adding CO2 detectors immediately outside each sleeping room and in rooms with fuel fired appliances.

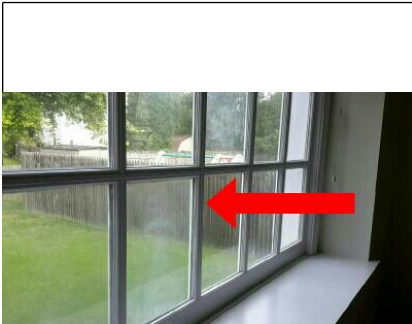
Comments Evidence of leaking insulated glass. Recommend repair/replacement of window

Leaking insulated glass
